# **Rebuttal Expert Report of Konrad J. Banaszak**

Case No. 13-cv-50348

**REBUTTAL EXPERT REPORT**

**KONRAD J. BANASZAK, PH.D.**

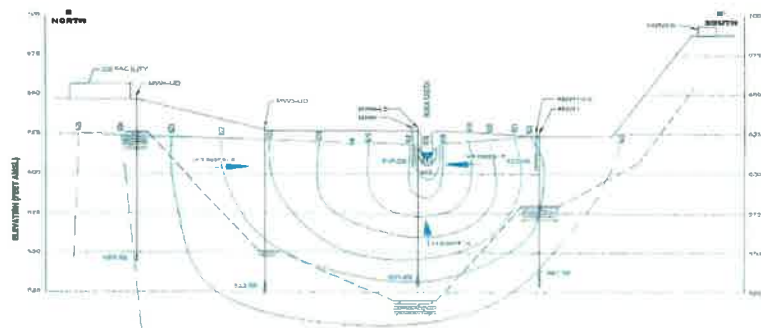
Dr. Vagt's Exhibit I. Cross Section B-B' with Potentiometric Plot  
Vertical Scale Modified to Match Exhibit K

2. Dr. Vagt's Exhibit I disagrees with known information. The cross section does not show the existence of the pond south of Rock Creek that is certainly there and is shown in Exhibit F. Exhibit K also disagrees with known information. The south supply well is in the wrong location, and accordingly at the wrong elevation.

3. Putting Dr. Vagt's Exhibits I and K together, the attached Figure 1, shows that Dr. Vagt has presented two different ideas with respect to groundwater flow. Exhibit I corresponds to all the mathematical analyses by Dr. Vagt, but the direction of the hydraulic gradient conflicts with the major direction of groundwater flow shown on Exhibit K. Dr. Vagt states that on his Section B-B', "Arrows have been added to show the directions of the gradients that drive groundwater flow on the north and south sides of Rock Creek and groundwater flow below the creek," (See p. 4-4, Section 4.1.2 of Dr. Vagt's Expert Report) and "it is the gradients, not the stratigraphy that drive groundwater migration (See p. 5-5 of Dr. Vagt's Expert Report, second paragraph under Part B)." Yet Dr. Vagt's own Exhibit K clearly shows stratigraphy is more important, as the main flow is down the upper bedrock zone. Flow like that shown on Exhibit K, not like that shown in Exhibit I, would allow contamination to reach the deep gravel and the broken up bedrock which is tapped by monitoring wells MW7-LS and MW8-LS, both adjacent to Rock Creek.

According to the flow postulated in Dr. Vagt's opinion based upon Exhibit I, all of the water flowing into layers 3 and 4 and the water flowing in the clay portion of layer 1 of Exhibit K must come from Dr. Vagt's layer 4 under the GE facility to the point where the top of the clay portion of layer 1 intersects the top of layer 4. These observations make the calculations (presented later in Dr. Vagt's opinion) of amounts groundwater moving in various zones to Rock Creek dubious at best.
